Holy Trinity, Cloudesley Square: Summary timeline of works and repairs, 1811–1980

NLHF Tales from the Crypt project

Rebecca Preston, September 2019

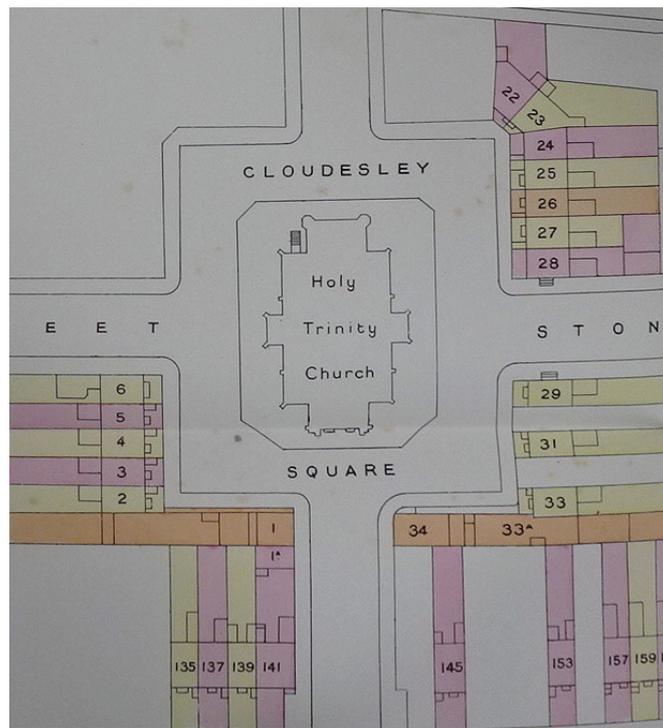
*Detail of Plan of a portion of the Stonefields Estate, 1937, showing the church as it was prior to c.1867–8
Courtesy of Islington Heritage*
